Final Report on

NASA Grant NSG-3024

RESEARCH INTO THE USE OF PYROLYTIC OXIDES AND POLYMERS FOR THE FABRICATION OF THIN FILM HIGH ENERGY CAPACITORS

**Joseph H. Nevin, Professor and Assistant Head
Department of Electrical and Computer Engineering
Solid State Electronics Laboratory
University of Cincinnati
Cincinnati, Ohio 45221**

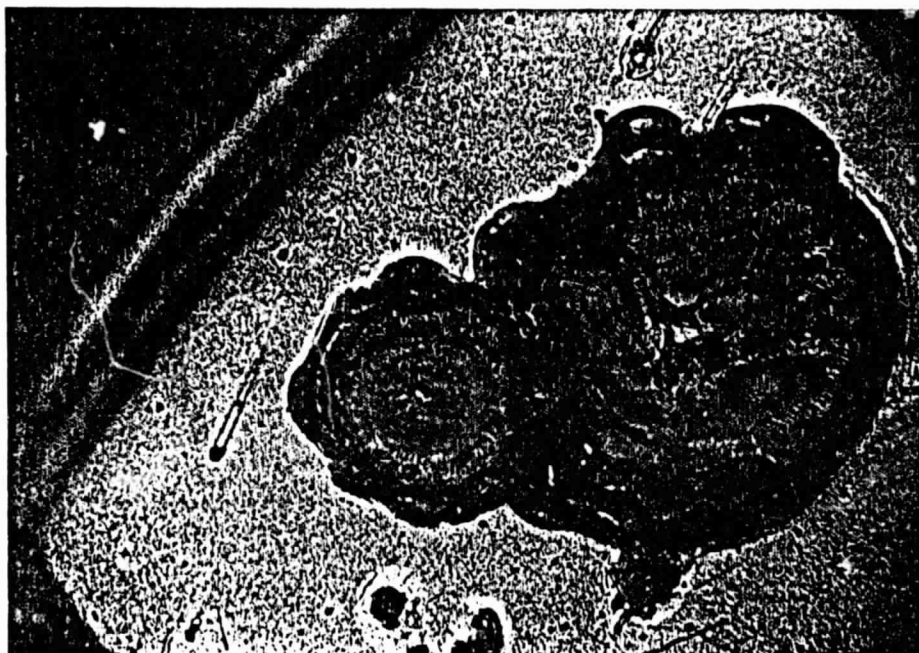
Fig. 34. Electrode damage at the contact area when shorts are blown out.

After every layer the capacitors were checked to see if any shorts had formed. If any were found they were blown out by discharging a $40\mu\text{F}$ capacitor which had been charged to about 70 volts through the shorted capacitor. Occasionally it was necessary to charge the capacitor to 120 V in order to have sufficient energy to completely blow out the short. Whenever a short is blown out it was necessary to contact the electrodes with point tip probes. This resulted in appreciable electrode damage as shown in Fig. 34.

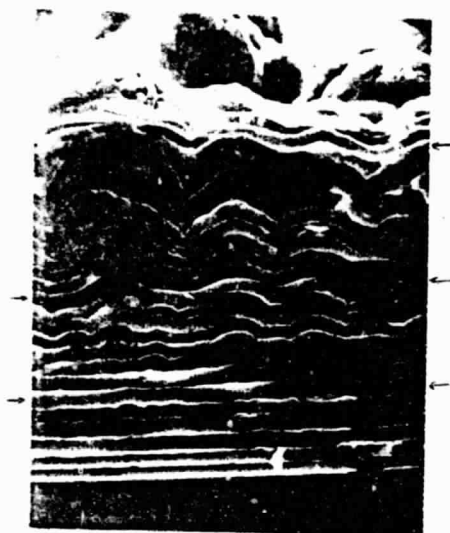
Fig. 46. SEM photo of the cross section view of a 25 layer capacitor in which the 6th, 13th and 22nd layers (marked with arrows) have a spin-on PSG layer added to help reduce the surface roughness.
